LOWER PAJARO RIVER ENHANCEMENT PLAN

FOR
GREEN VALLEY, CASSERLY, HUGHES,
TYNAN, COWARD AND THOMPSON CREEKS
SANTA CRUZ COUNTY, CALIFORNIA

DECEMBER 2002

FINAL REPORT

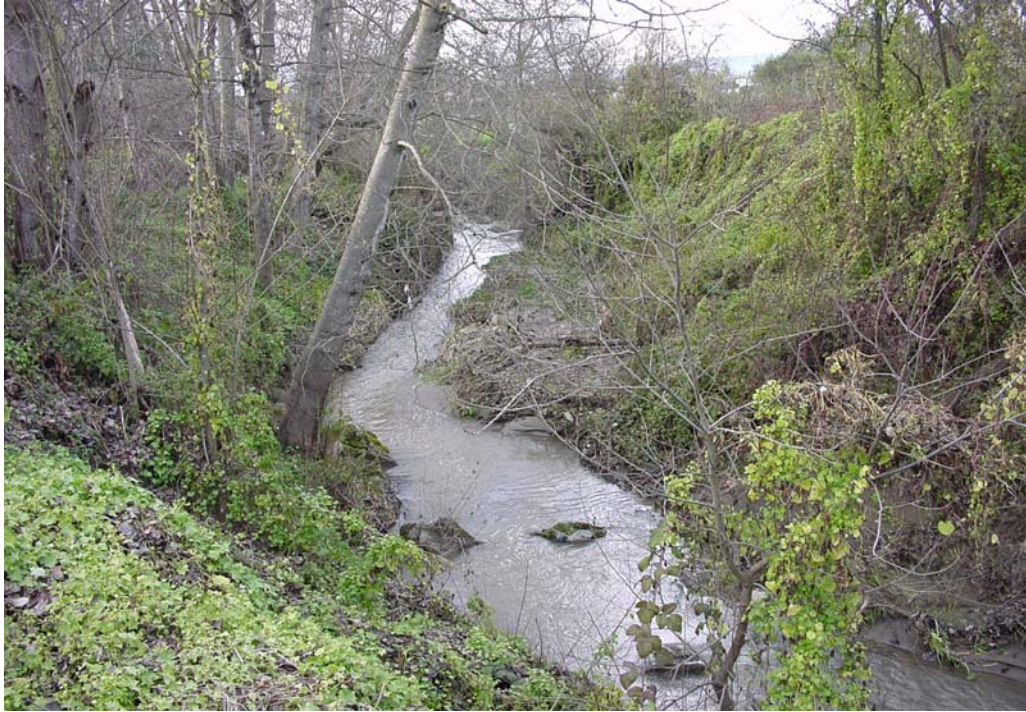
Figure 3.6. Lower Reach of Green Valley Creek

This watershed above Casserly Road has little native riparian vegetation. In some areas, golf course turf provides some vegetative protection of the channel banks, but rooting depth is shallow in these areas. In other areas the turf appeared to be dead or was missing altogether leaving exposed dirt streambanks. In the stream reach just above Casserly Road, below the golf course, top of bank vegetation consisted of eucalyptus plantings and a flower farm with no side bank vegetation. Immediately downstream of Casserly Road, an almost continuous arroyo and yellow willow overstory and blackberry understory provide effective protection of the right streambank. Mature willows at the top of bank provide a good buffer from adjacent agricultural land uses. The left bank has a more discontinuous canopy cover of willow with dense Himalaya berry understory providing moderate bank protection. Further downstream, review of aerial photos showed a reduced riparian canopy and understory.

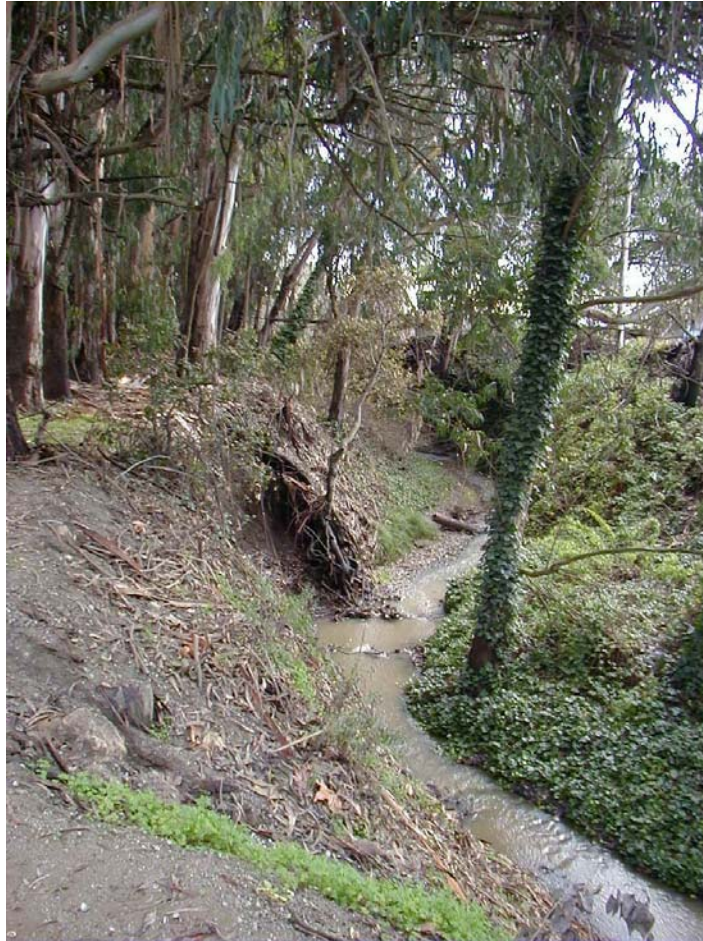
Figure 3.7. Casserly Creek

In summary, the minimal or no setbacks from the riparian corridor combined with loss and removal of riparian vegetation are contributing to additional channel downcutting, bank instability, and sedimentation in the area of Paulsen Road.

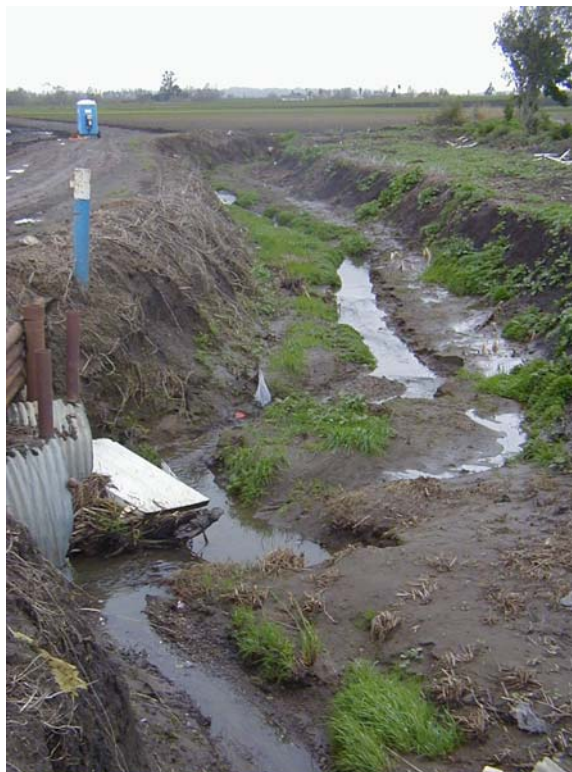
Figure 3.8. Tynan/Martin Creek downstream of Tynan Lake

The biggest issue facing the Tynan-Martin Creek watershed is aggradation of the channels from excessive sediment loads. There are several areas where the channels have been completely buried by fine sediment, resulting in clogged culverts and ponded water during the winter season. Of the approximately 4 miles of channels surveyed, 75% are rated as having a very high to extreme erosion potential. Loss of permanent riparian vegetation, annual removal of herbaceous vegetation just prior to the rainy season, channel modification, and minimal to no setbacks of buffers are resulting in substantial erosion and sedimentation in the entire Tynan subarea.

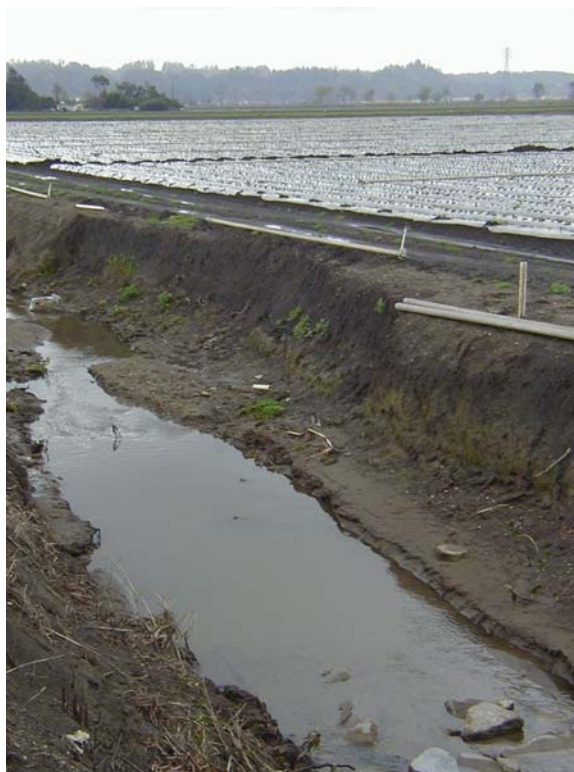
Figure 3.9. Tynan/Martin Creek Upstream of Highway 129

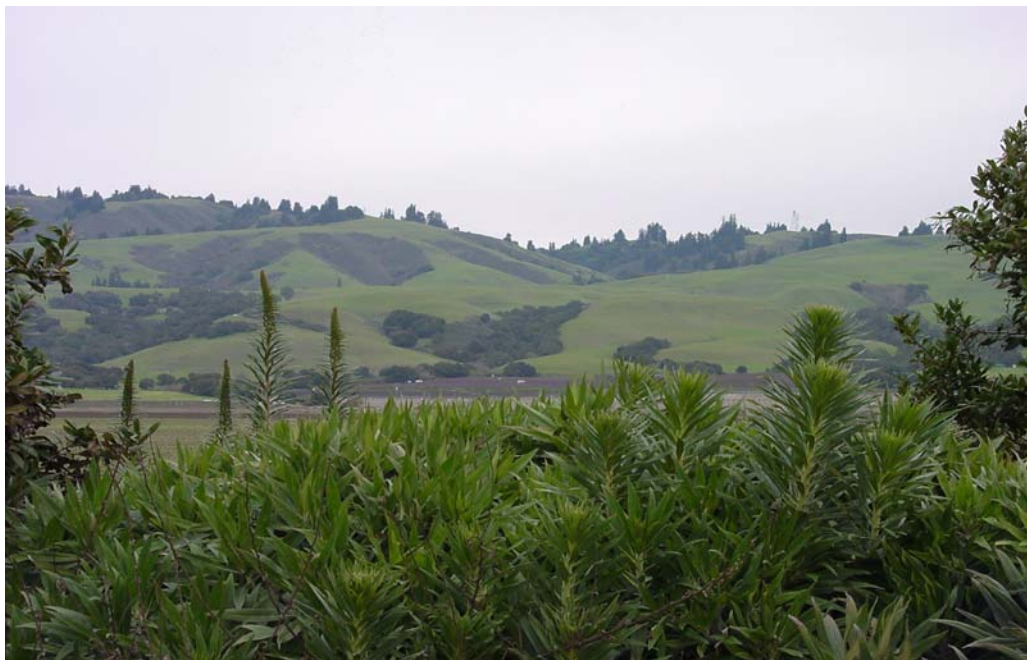
Figure 3.10. Upper Coward Creek Watershed

The characteristics of the upper watershed result in a large amount of natural sediment production. As the creek reaches the valley floor and moves towards lower Carlton Road and Highway 129 this sediment is deposited in the channel, which results in channel aggradation (filling). Maintenance of the channel is necessary to maintain the viability and value of the agricultural lands adjacent to the creek. This reach of Coward Creek has no riparian vegetation and agricultural setbacks are minimal. Landowners, leasees, and/or the County Drainage Division sporadically clear the channel. Intermittent clearing and unstable banks lead to chronic and acute erosion problems in this area.

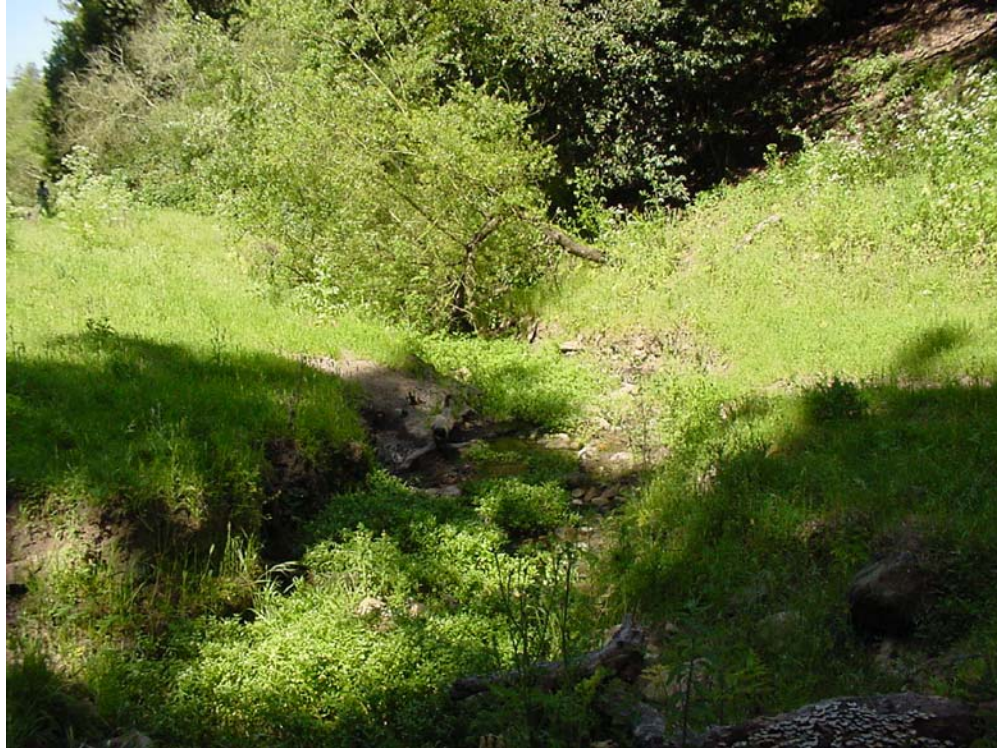
Figure 3.11. Upper Coward Creek

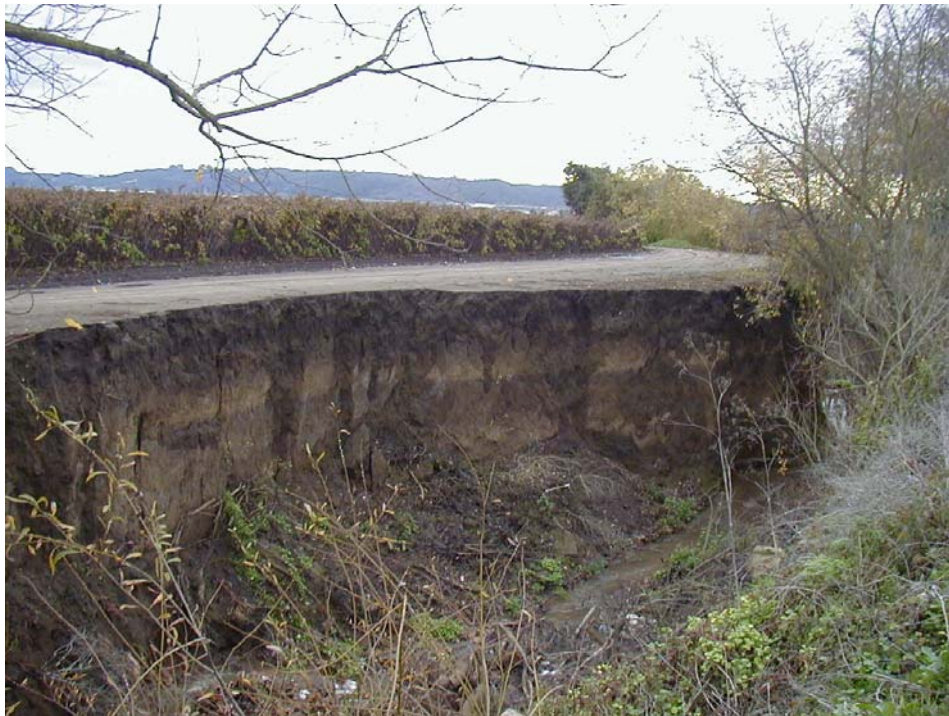
Figure 3.12. Bank Failure on Coward Creek along Carlton Road

Localized flooding in the area of Thompson and Carlton Roads, as well as substantially flooding due to breaches of the Coward Creek levee below Highway 129 were reoccurring events during the wetter than average period in the later 1990's. Jim Rider's home ranch is largely on the nearly level valley floor. In 1998, the company office and processing buildings were flooded when Coward Creek overtopped its banks. This occurred during the same storm event that led to the undercutting and loss of a substantial length of Carlton Road upstream (Figure 3.12). Debris from the bank failure clogged the Coward Creek culvert near the intersection of Thompson and Carlton Road causing the creek to overtop the channel. Mr. Rider noted that there has been no consistent or coordinated maintenance/renovation of the Coward Creek channel in this area. Due to topography and continued sedimentation in the lower stretch of the creek, the bottom of the channel is actually higher than much of his property. There is a long stretch (about 800 feet) of the channel south of Carlton Road that is sporadically dredged out by the grower leasing the adjacent parcel. Typically sediment is simply piled up along the bank of channel and eventually erodes back into the creek in the winter.

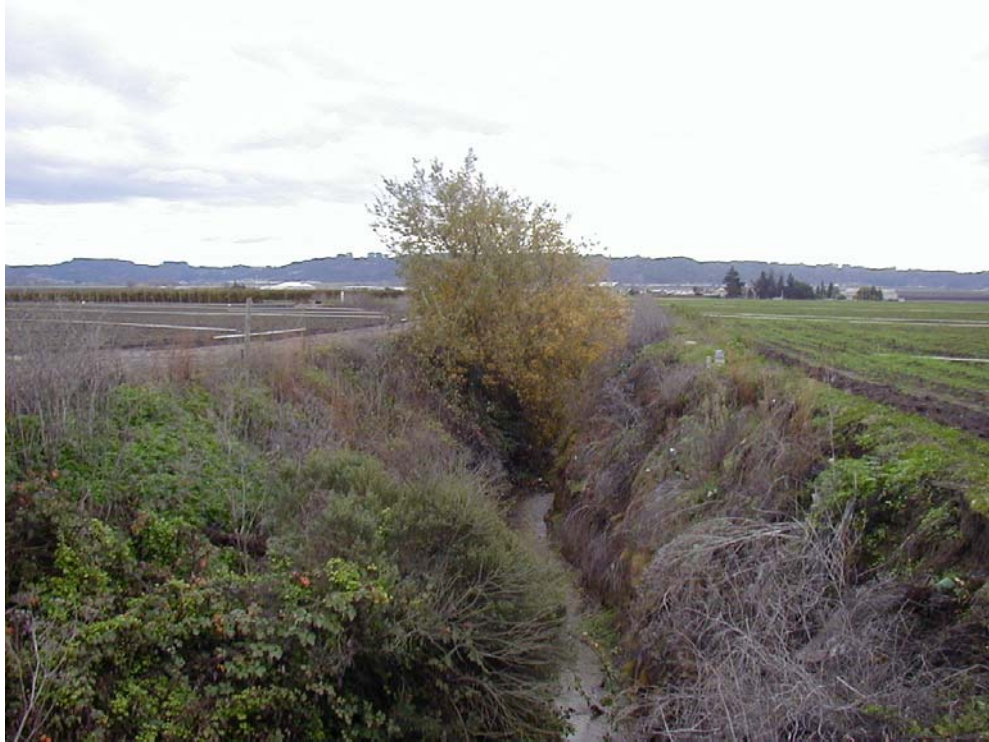
Figure 3.13. Coward Creek Downstream of Carlton Road

In reaches where vegetation is well established, the banks are typically more stable, as can be seen immediately downstream of the large bank failure on Coward Creek (Figure 3.13).

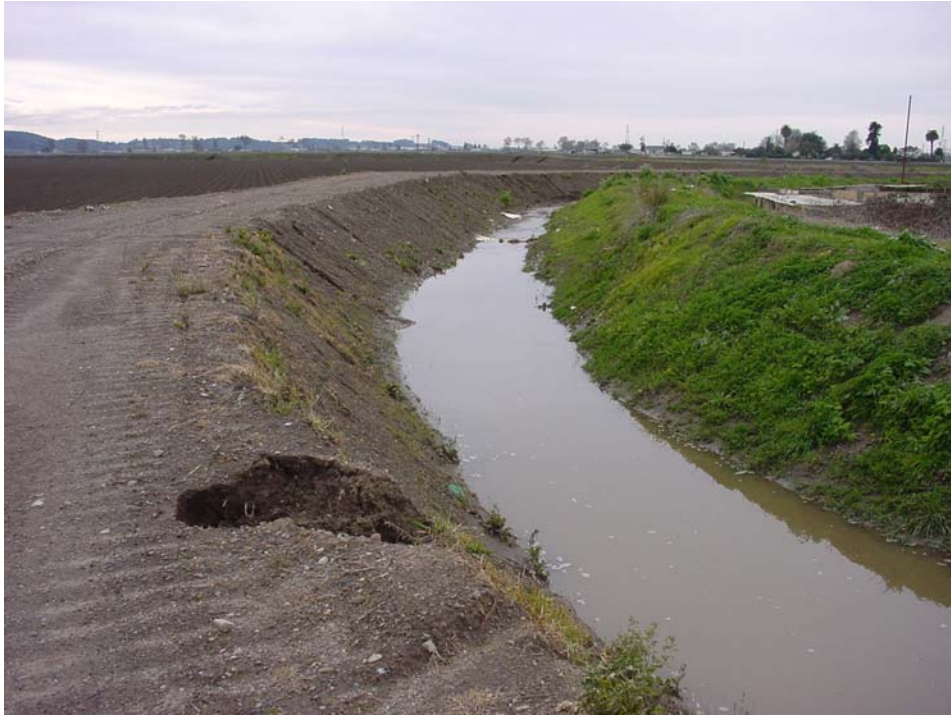
Figure 3.14. Lower Coward Creek downstream of Highway 129

lower channel continue to result in excessive bank instability, erosion, localized flooding, and sedimentation.

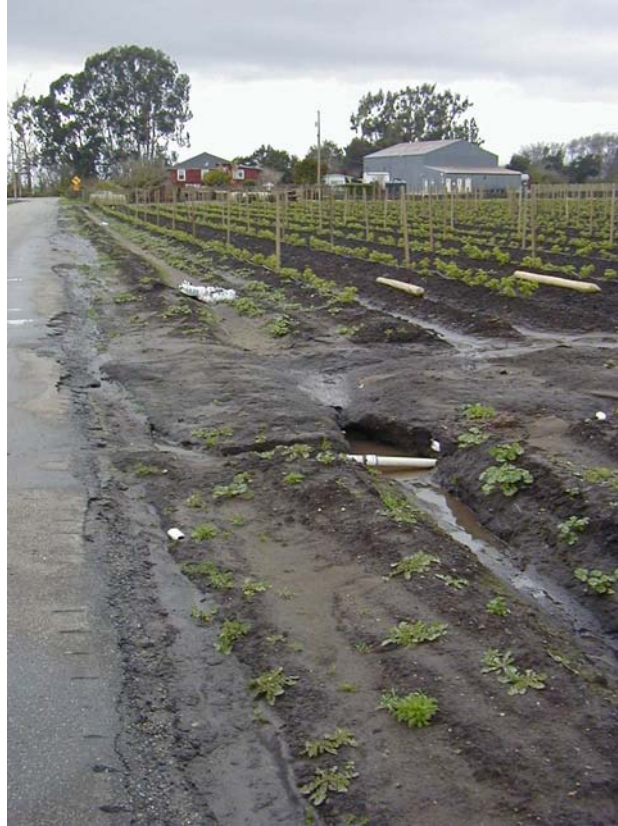
Figure 3.15. Drainage ditch along Thompson Road

Above Thompson Road an old grassed ditch conveys water from the lower portion of the Porter Ranch towards a culvert running under Thompson Road. Between this ditch and the road are fields that in the past 10 years have been converted from apples to vegetable and berry row crops. In the winter these fields (dependent on crop rotation) can generate large volumes of runoff that is discharged into the aforementioned ditch or into the road ditch along Thompson Road. This has led to erosion of the south shoulder of the road, and alternately down cutting and sedimentation of the ditch as it flows into the upper Thompson Road culvert. Flow out of the culvert is also eroding the ditch and conveys this sediment into another ditch system that leads to the Kelly-Thompson Ranch. Poor winter runoff management in recent years is both undermining the road and exposing buried irrigation piping in this area (Figure 3.15).

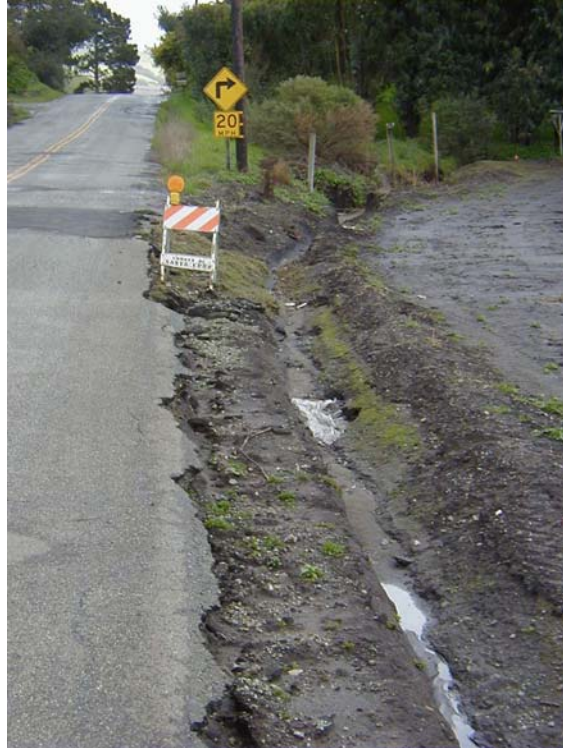
Figure 3.16. Road damage from drainage along Thompson Road

Just below the 90-degree turn on upper Thompson Road, winter runoff and irrigation tailwater is discharged from all of the fields to the northwestern side of the road. Runoff enters a poorly defined and maintained roadway ditch. This system routinely fails each winter releasing a substantial amount of sediment on Thompson Road or into the road ditches and conveyed down the ditches to an old and now undersized culvert. Runoff from this area is drained to an open channel ditch that runs along Carlton Road. Conversion of orchards on the northwest side of Thompson Road to strawberry and vegetable row cropping has dramatically increased the volume and velocity of runoff and increased erosion of tailwater ditches conveying this water to Thompson Road (Figure 3.16). Annually, landowners in the area must remove sediment from the road, driveways, parking area, and, in some years, the inside of buildings. Portions of the road ditch have been removed and paved for driveways and there has been no coordinated maintenance of this ditch in years. Long time owners of property in this area have no memories of this ditch being maintained.

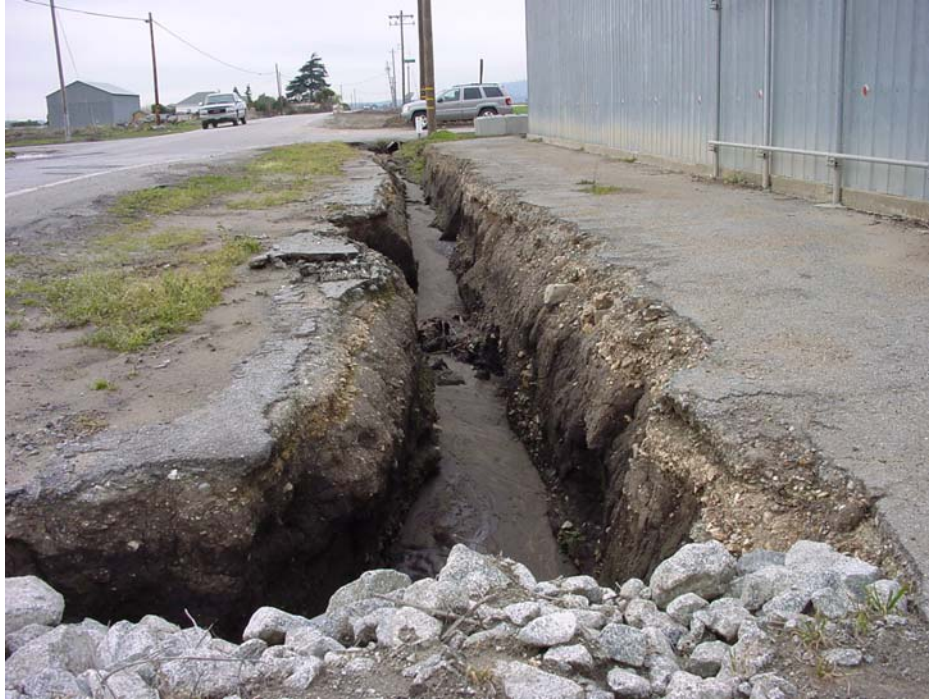
Figure 3.17. Drainage Ditch at Thompson and Carlton Roads

Mr. Scurich has installed a concrete barrier around his cooler to prevent sediment and water from entering his site and building. His property along Carlton Road is being undermined by erosion of the road ditch due to the high runoff rates from the Thompson Road (Figure 3.17). When the culvert is clogged and overloaded, runoff and debris enters Mr. Rider's property. To mitigate these impacts and protect his property and fields, in 1995 Mr. Rider installed a large ditch and berm along the northeast side of Carlton Road.

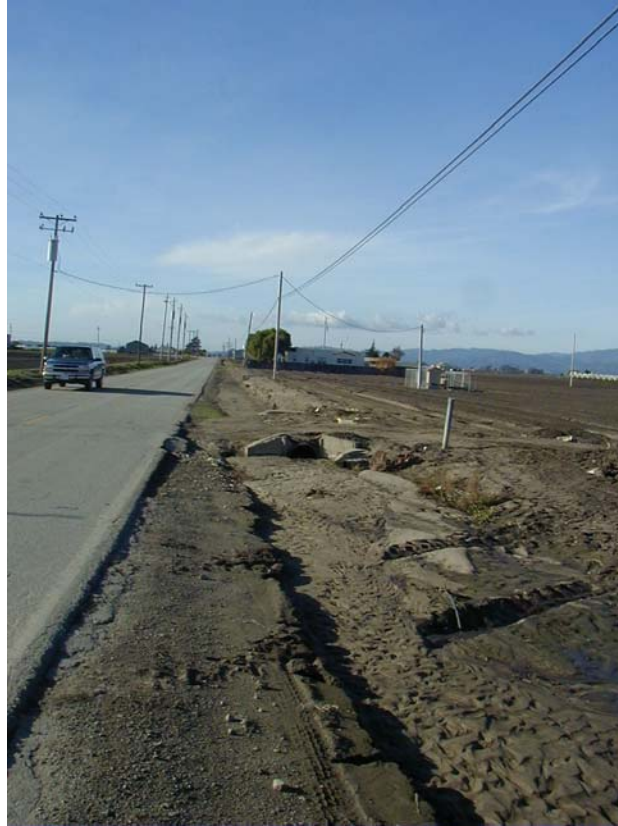
Figure 3.18. Drainage ditch along Carlton Road

The lower portion of the Kelly-Thompson Ranch has two main channels that convey water originating on the lower portion of the rangelands on the ranch and the drainage from the lower portion of the Porter Ranch. The steep canyons in the upper watershed (largely Aptos and Los Osos loam soils) that convey high flows that transport large amounts of sediment that tends to be deposited in the lower channel reaches. In the mid-1980's conversion of a portion of the ranch from apples to row crop resulted in the relocation of the natural creek channel. Prior to this, the sediments transported from the uplands were deposited in the channel and floodplain of this creek with no harm to the orchards. In order to have viable row cropping, the relocation of this channel required construction of a large ditch and the construction of a sediment pond near Highway 129 (Figures 19 and 20). Sedimentation of these channels is a chronic problem and every year approximately 10,000 cubic yards of sediment is removed to maintain channel capacity (Fred Silva, personal communication). Currently, drainage systems from this ranch, the lower Porter Ranch, and the Thompson Road area enter a small sediment pond constructed by the Kelly-Thompson Ranch as a interim measure to control runoff and capture sediment to minimize flooding problems at Highway 129. Two culverts under Highway 129 drain this pond.

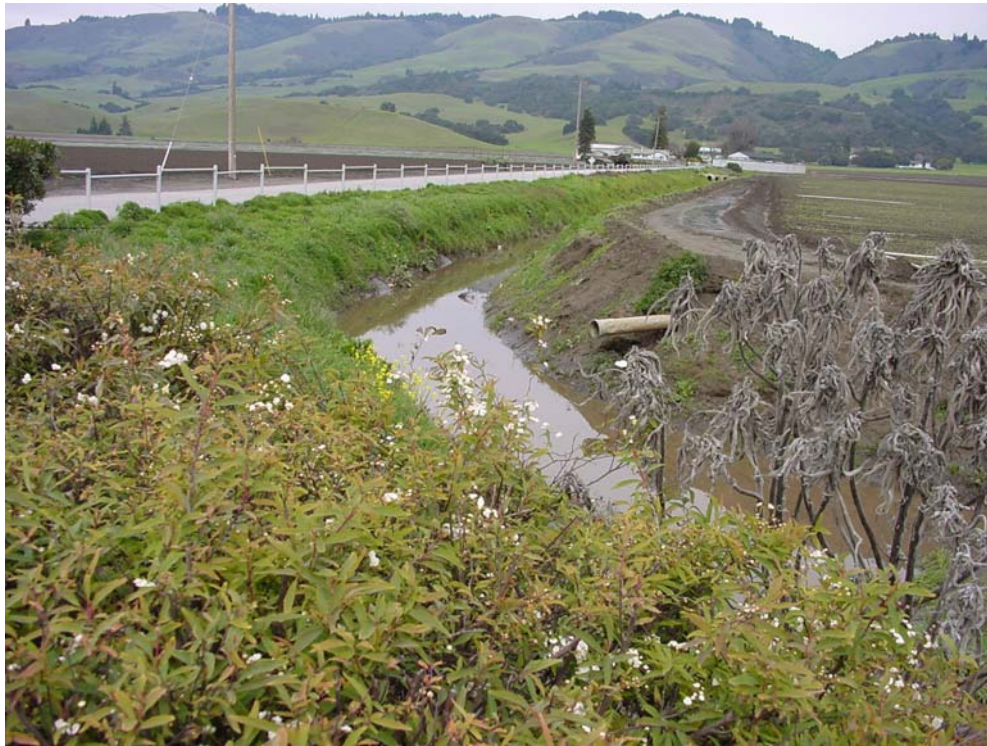
Figure 3.19. Kelly-Thompson Creek

and poorly positioned culvert. Aggradation of land on the south side of Highway 129 has furthered compromised the function of the sediment pond and culvert.

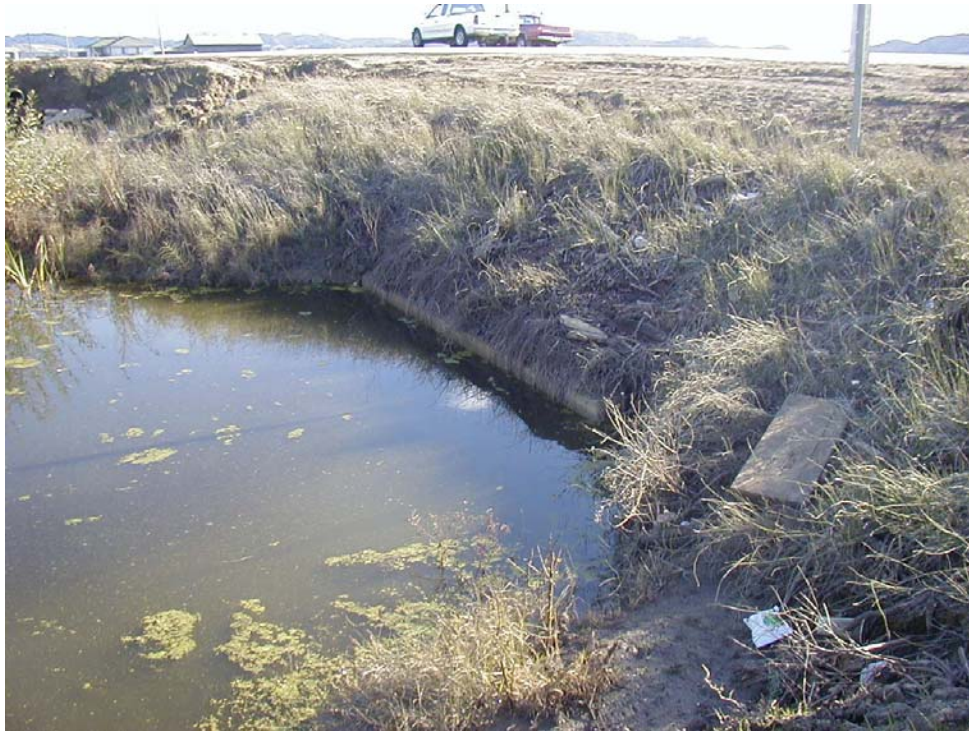
Figure 3.20. Kelly-Thompson Sedimentation Pond/Culvert at Highway 129

This area represents a relatively small drainage that is separated from Tynan, Coward, and Thompson Creeks. This drainage begins above Highway 129 along the south side of Carlton Road, where a ditch and berm, maintained by Jim Rider conveys excess runoff from upper Thompson Road, southwest to a culvert under Highway 129 (milepost 3.15). In the late fall of 2000, this culvert was found to be completely clogged by soil and weeds that apparently accumulated over the past three winter seasons. When this drainage system is maintained, runoff enters the culvert under Highway 129 and a channel that used to run south to the Pajaro River. However, this channel is currently not maintained and the channel and direction of flow is not well defined. A second ditch parallel to Highway 129 currently receives runoff from the highway and this ditch has no outlet and appears to be maintained by growers to prevent runoff from Highway 129 from reaching fields along the south side of the highway.

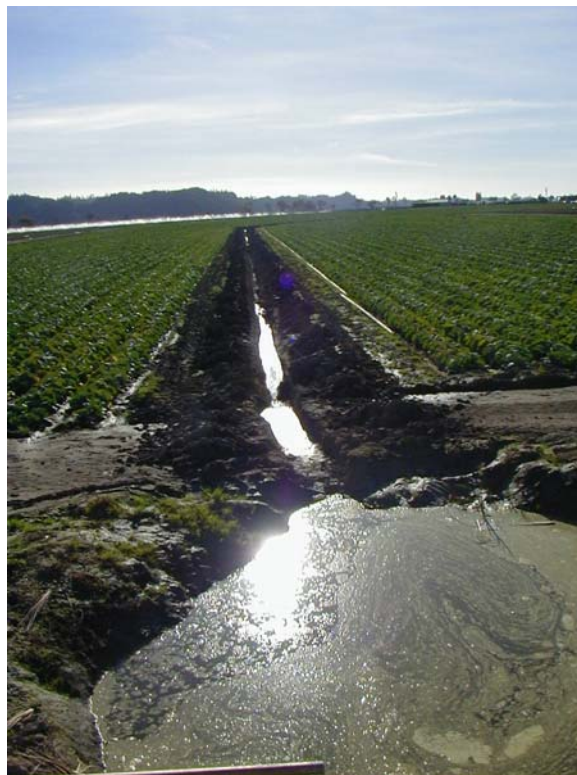
Figure 3.21. Kelly-Thompson ditch downstream of Highway 129

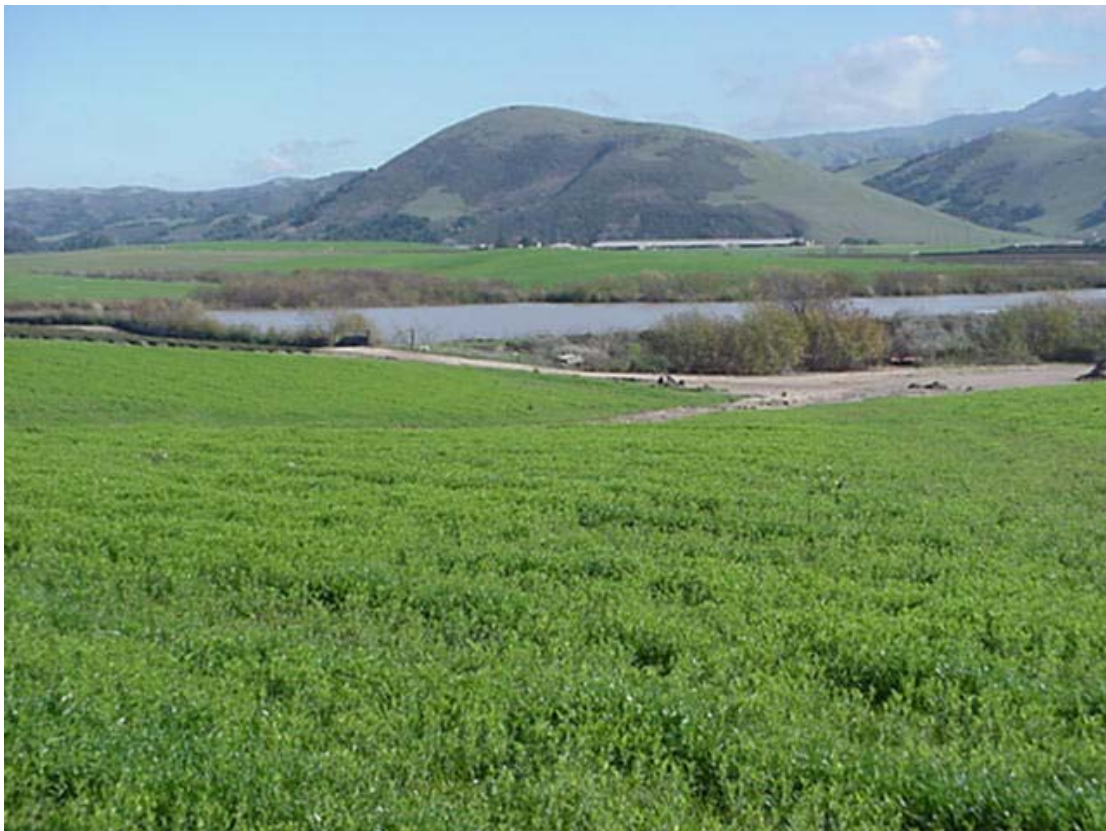
Figure 6.5. Cover Cropping

Benefits	Constraints
<ul style="list-style-type: none"> • Prevents soil erosion • Conserves soil moisture • Protects water quality • Reduces fertilizer costs • Reduces the need for herbicides and other pesticides • Improves yield by enhancing soil health 	<ul style="list-style-type: none"> • Cover crops may be habitat for pest species. • Cover crop uses soil moisture, in a dry farm situation this may be a consideration (however, research has also shown that cover crops can contribute to soil moisture during decomposition) • If allowed to go to seed, the cover crop may become weedy, if use a re-seeding type crop • Cover cropping may delay planting of winter or early spring crops

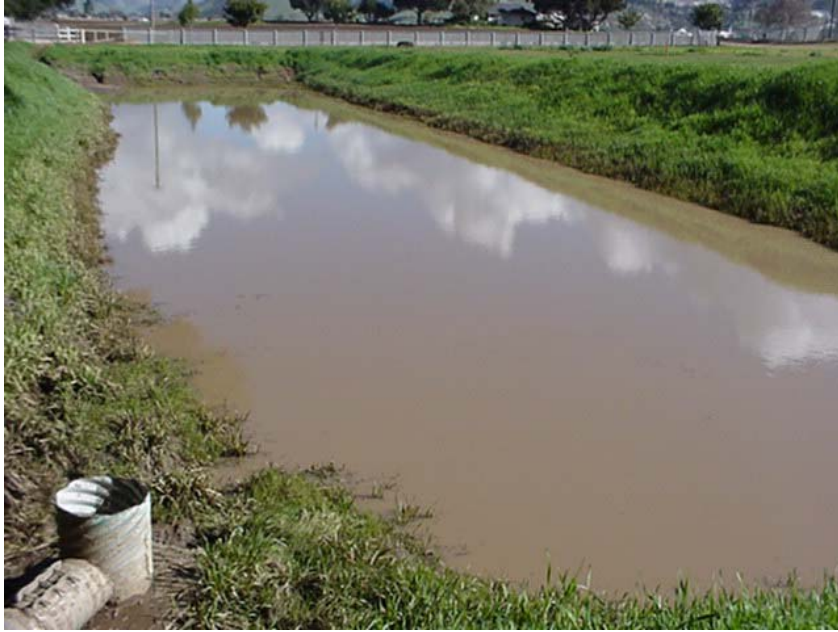
Figure 6.9 Typical Sedimentation Basin

The construction of a sediment basin creates a zone of land that is in continual contact with water. Proactive vegetation removal of the basin will keep it from being invaded by weeds. Another method to control unwanted vegetation in basins is to maintain a depth of more than 5' of water. Water at this depth prevents the growth of rampant vegetation such as cattails or tules. For a partial list of appropriate plants see the plant list in the above section "Grassed waterways". Other appropriate plants might include willows, sedges, etc. Basin design should allow for periodic dredging and bank re-shaping. These activities require access for an excavator or backhoe. In many circumstances the basins should be designed to fully drain within 24 hours of a storm and not remain full of water.

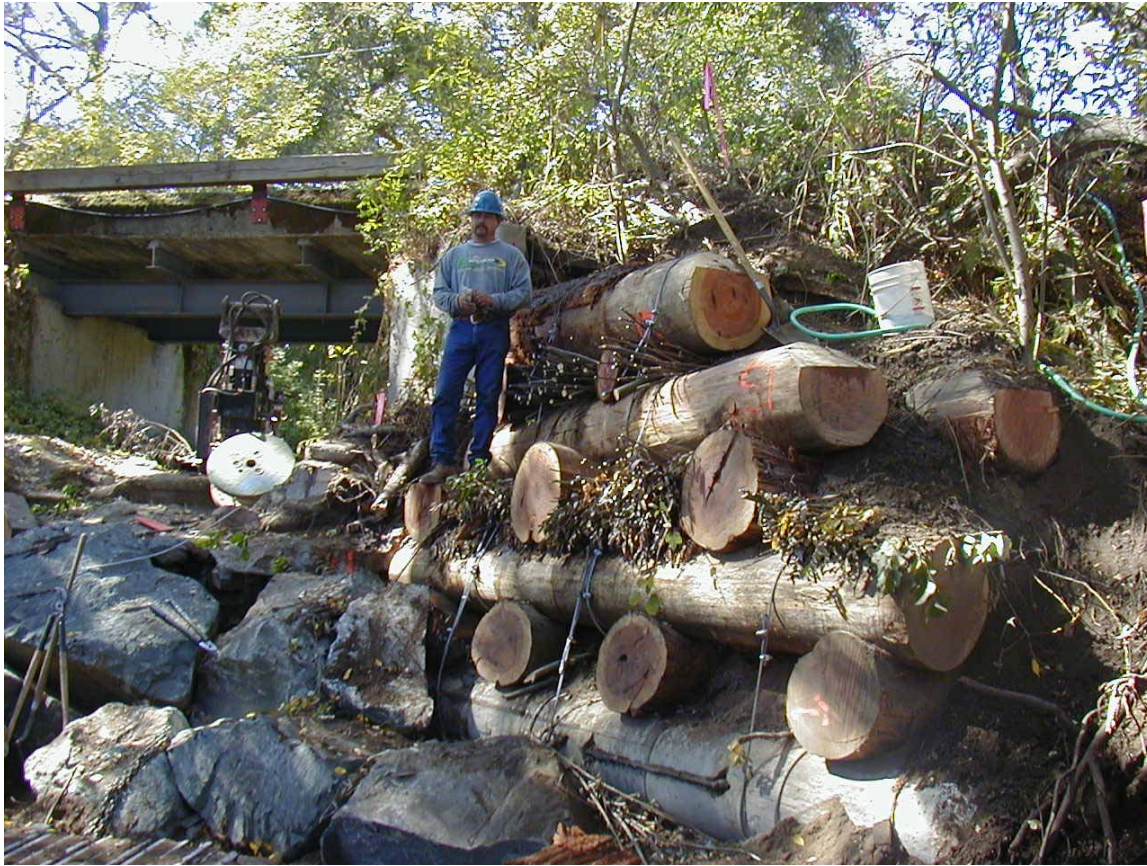
Figure 6.13. Redwood Log Crib Wall with Willow Stakes

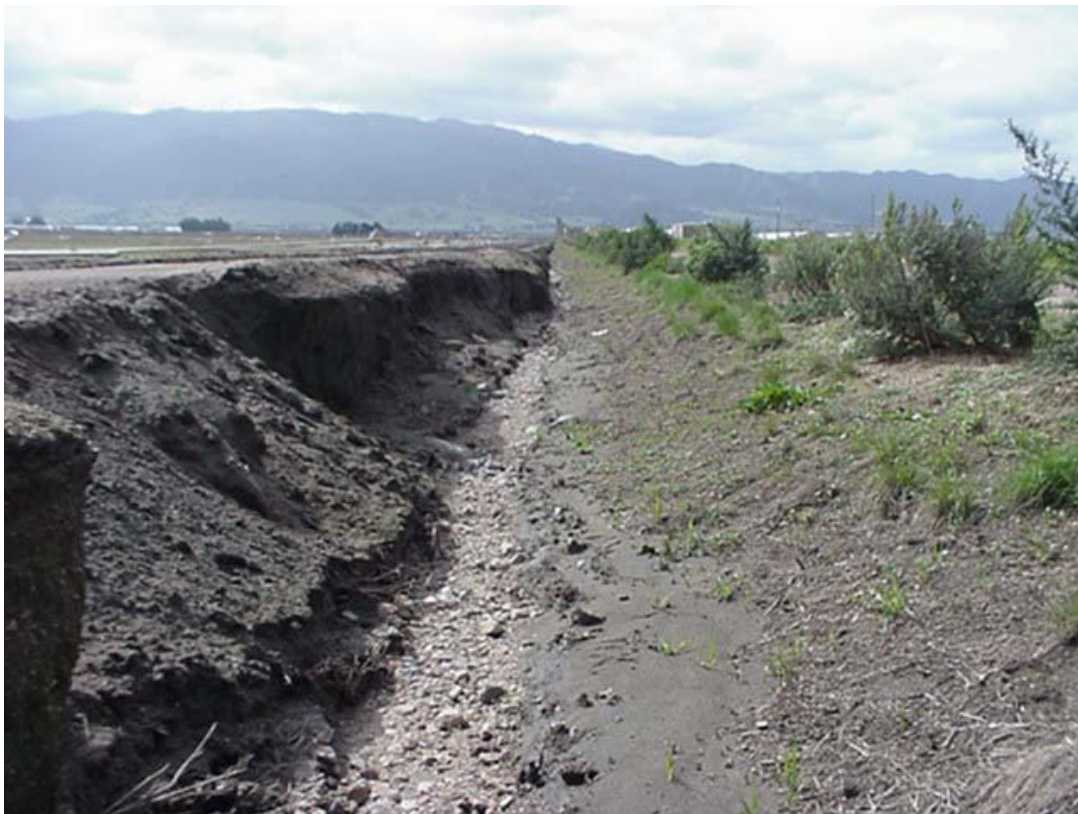
Figure 6.16 Comparison of Bank Reshaping on Waterway

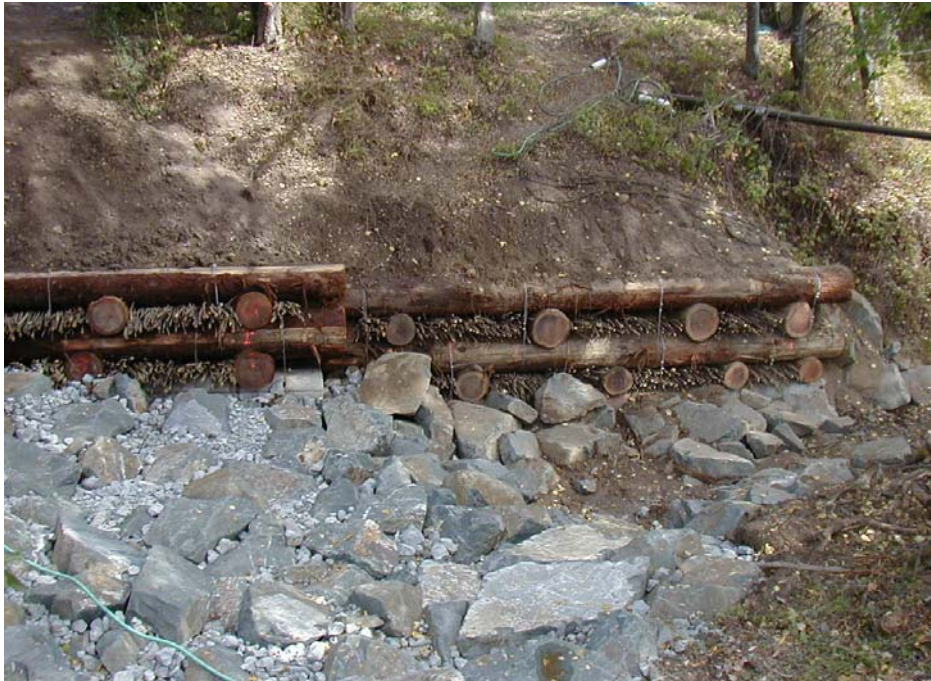
Figure 6.17 Log Bank Armoring Using Redwood Log, Soil Anchors and Willow Staking

stream bank they need to be secured in place using large boulders, a soil anchor system or other methods. Sediment will collect between the logs and the bank, providing a place for vegetation to establish.

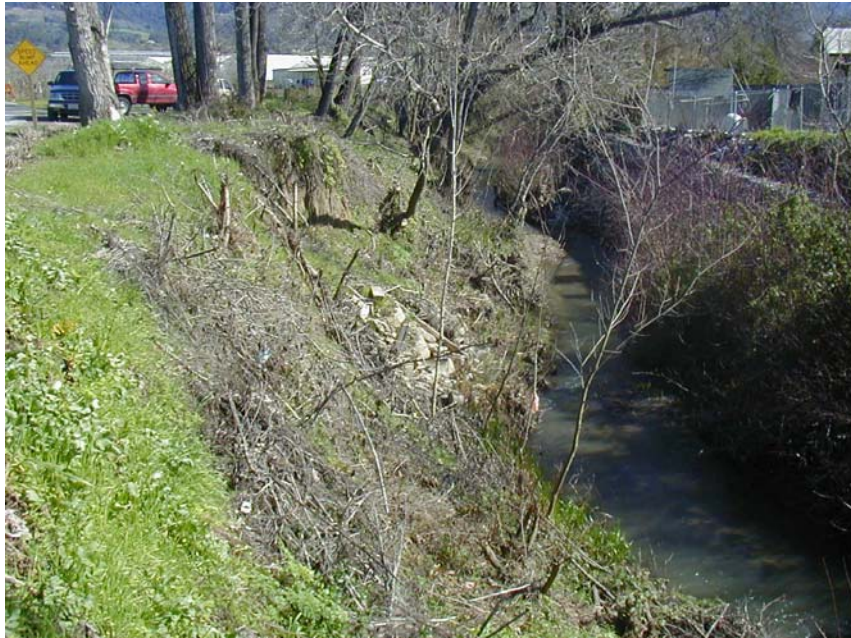
Figure 7.2 Bank Conditions at Site 1

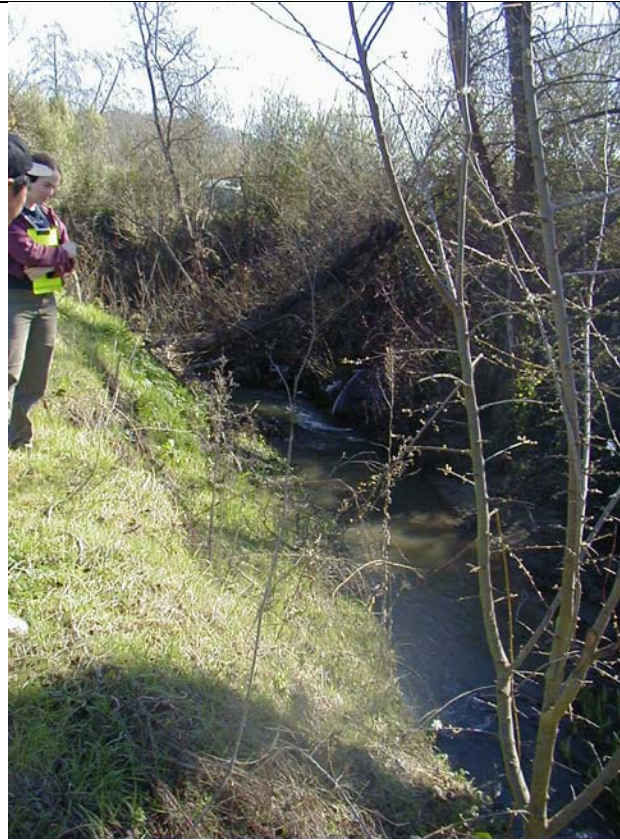
Figure 7.3 Bank Conditions at Site 2

At Site 2 the bank is nearly vertical and unstable. In this section of the stream, the channel is not as deeply incised as compared to the upstream site, and the top of the bank is approximately 6 feet above the channel. Due to the over steepened condition of the bank, erosion and slumping have occurred. Because of the steep slope of the bank there is virtually no vegetation on the bank.

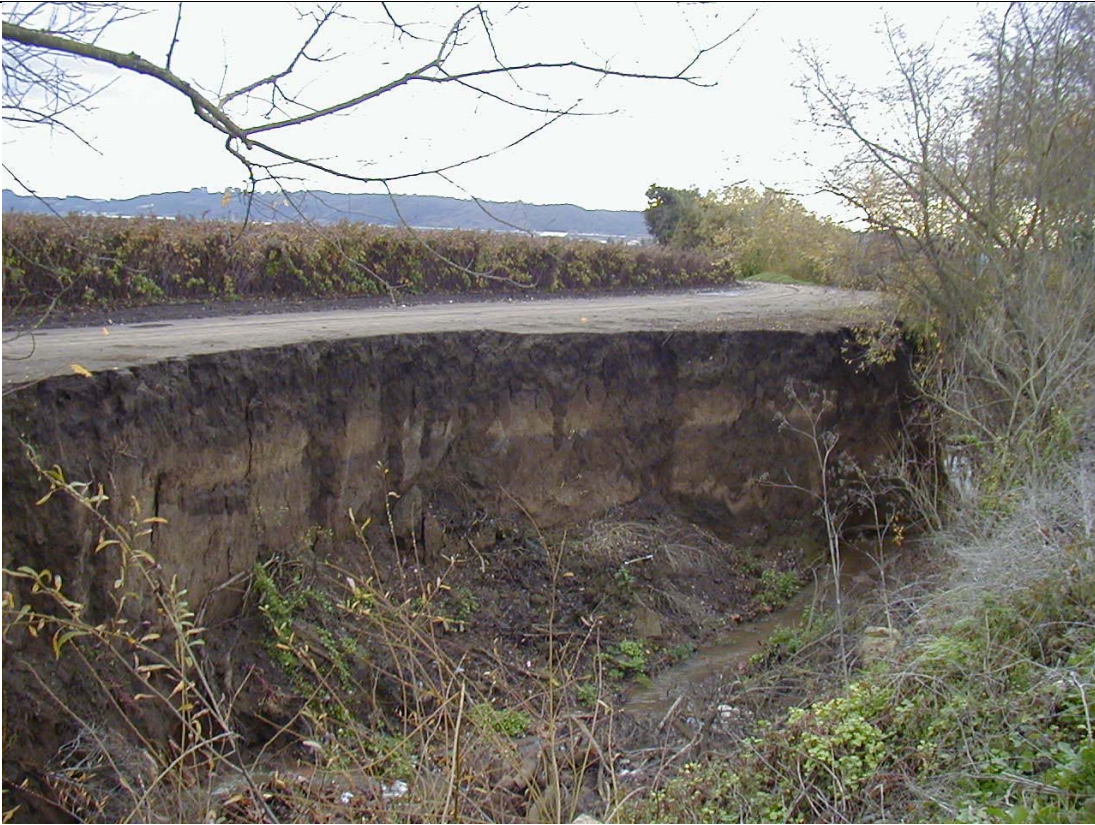
Figure 7.7 Streambank Conditions on South Side of Coward Creek Channel

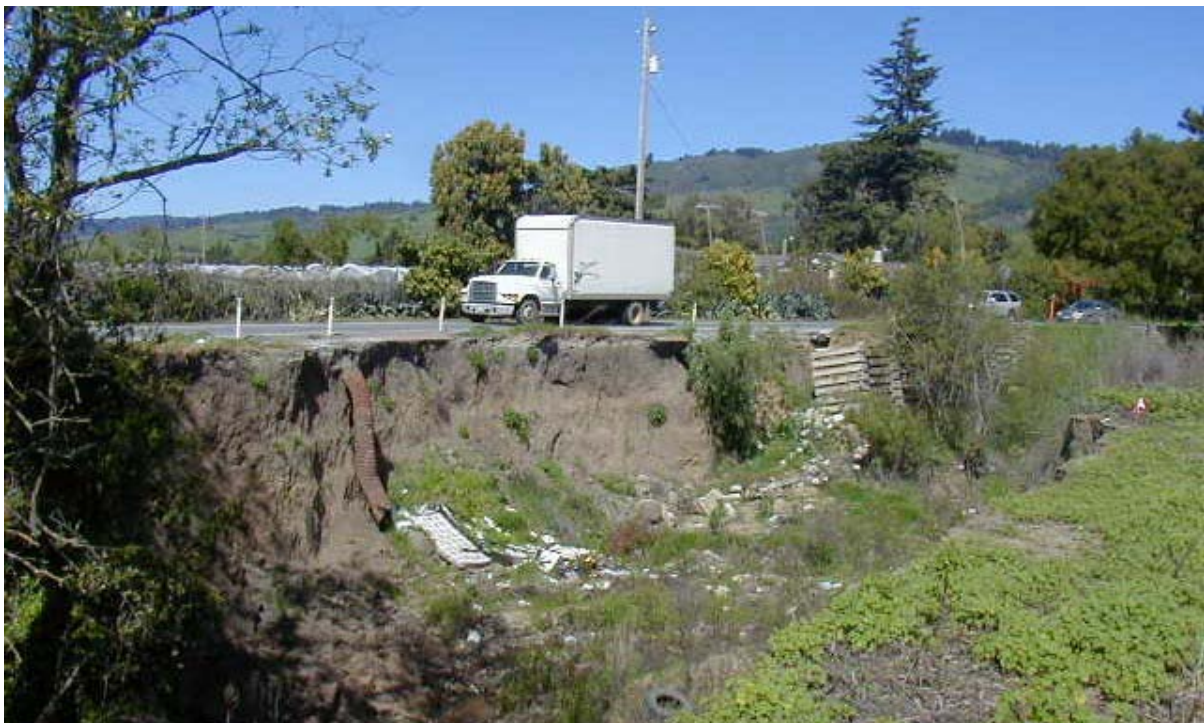
Figure 7.8 Carlton Road Side of Coward Creek
